June 2019

BLACKBURN CATHEDRAL

Quinquennial Inspection Report

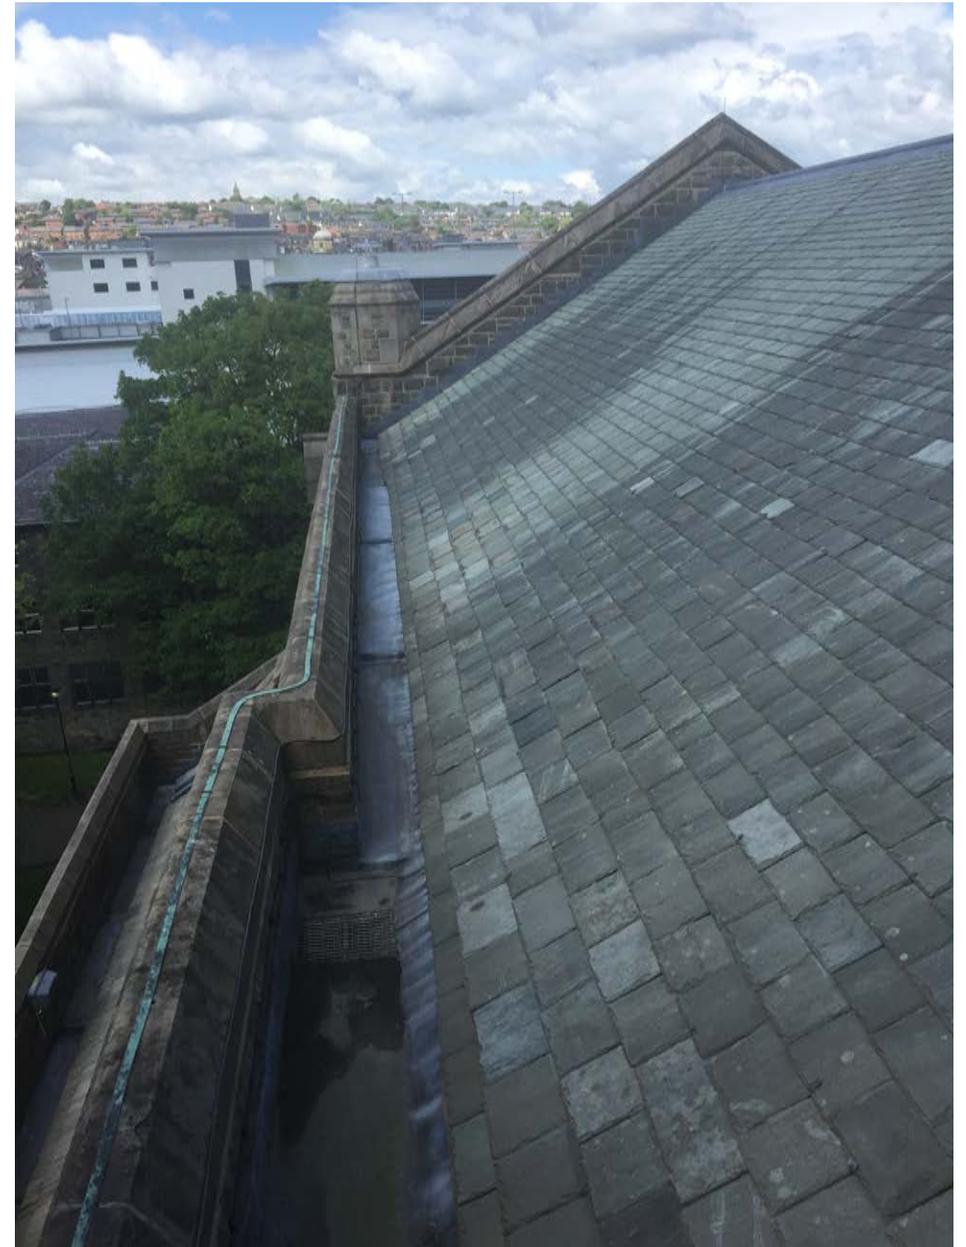
Completed WWI Round 1 works – North Transept

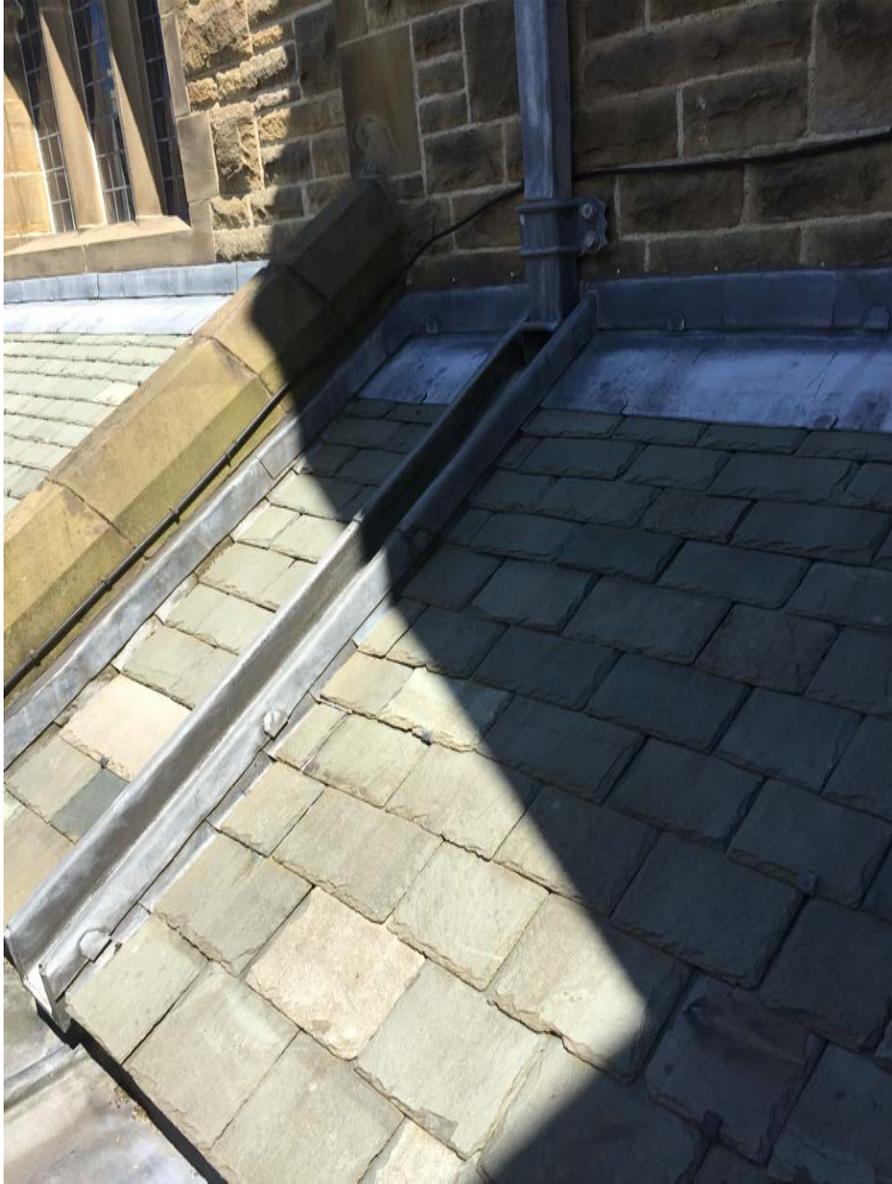
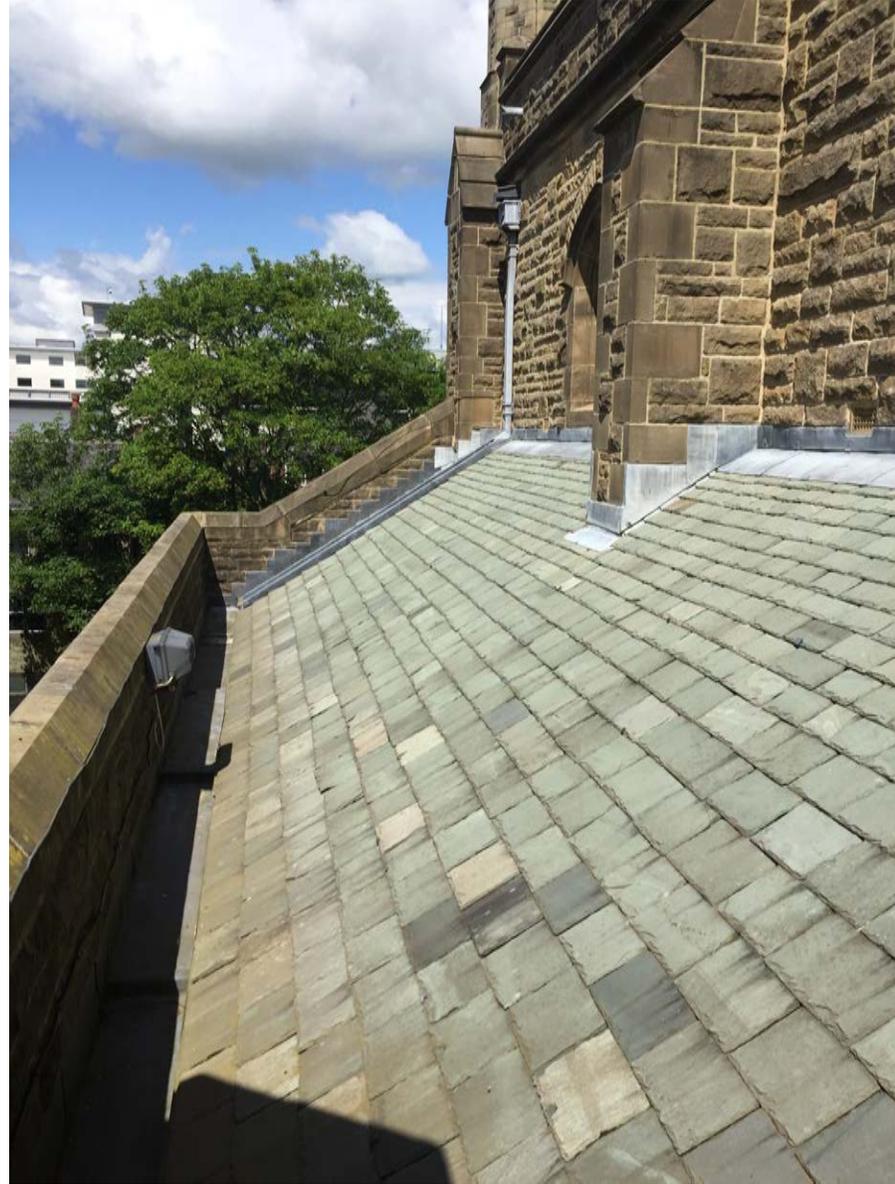
Completed WWI Round I works – North Transept Lower Roofs
